# TREATMENT OF A CARIOUS LESION WITH A SINGLE-POSTERIOR-SHADE COMPOSITE

WITH CLEARFIL MAJESTY™ ES-2 Universal

CLINICAL CASE WITH  
DR. NICOLA SCOTTI

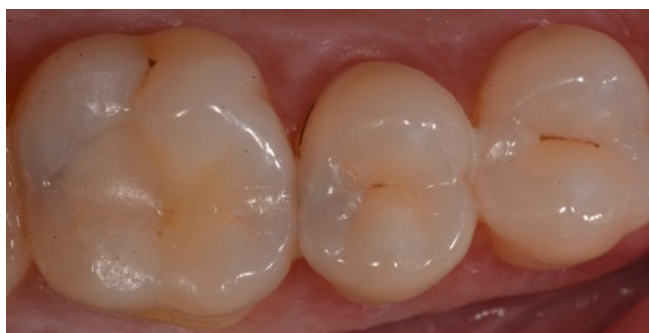
**Fig. 1.**

Initial situation with a wide primary carious lesion in the distal aspect of the second premolar.

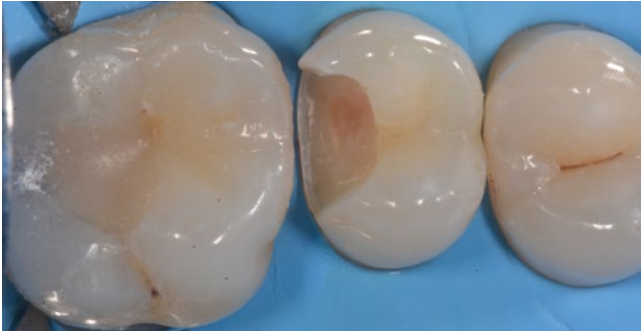
**Fig. 2.**

Premolar after isolation of the working field with rubber dam, caries excavation and cavity preparation.

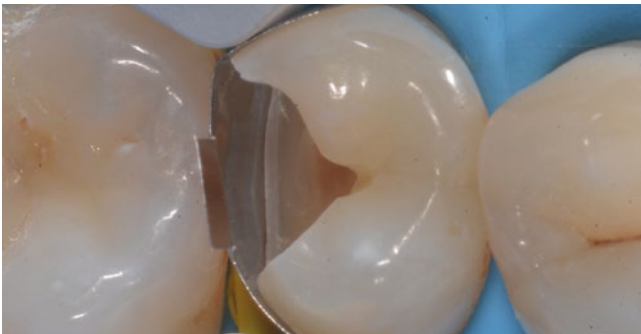
**Fig. 3.**

Placement of a sectional matrix and a wedge to optimize the fit. Both are held in place with a separation ring, which increases the interproximal space and hence ensures tight, anatomically correct proximal contacts.

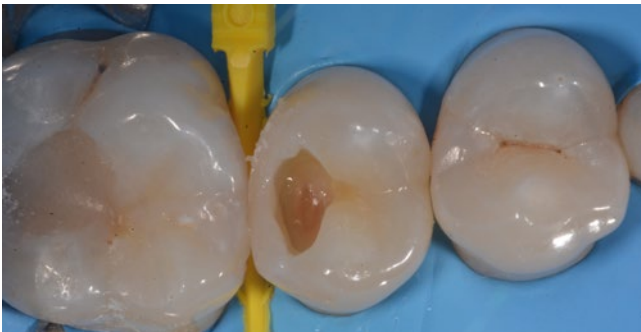
**Fig. 4.**

Build-up of the proximal wall with CLEARFIL MAJESTY™ ES-2 Universal (U shade) following selective enamel etching with phosphoric acid (K-ETCHANT Syringe) and bonding with CLEARFIL™ SE Bond.

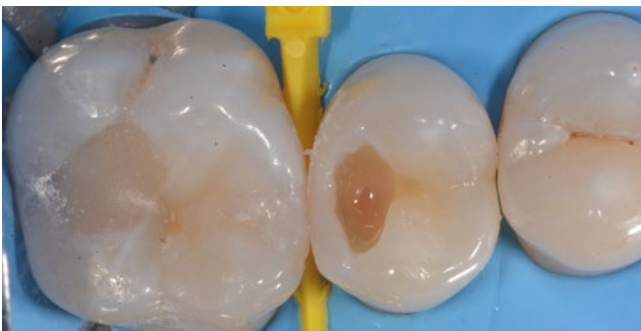
**Fig. 5.**

A thin layer of flowable composite (CLEARFIL MAJESTY™ ES FLOW High) applied to the cavity floor to act as a resin coat.

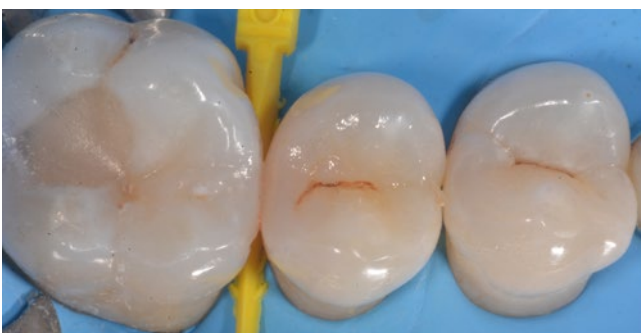
**Fig. 6.**

Restoration completed with CLEARFIL MAJESTY™ ES-2 Universal (U shade). While the universal-shade composite blends in very well with the surrounding tooth structure, the natural look is completed by adding a tiny bit of brown tint to the fissure.

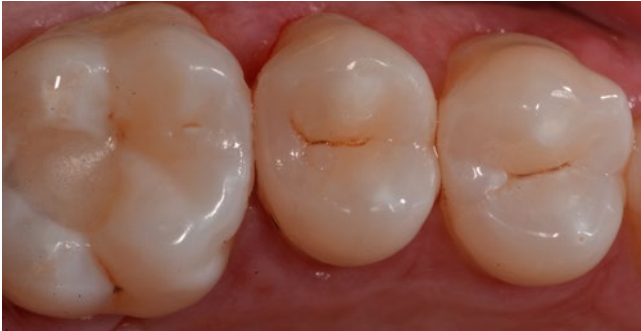
**Fig. 7.**

Treatment outcome immediately after rubber dam removal. The proximal contact is tight and the occlusal anatomy well-shaped for the patient's individual masticatory dynamics. The margin of the restoration is virtually invisible, while the buccal cusp appears lighter due to dehydration of the natural tooth structure.

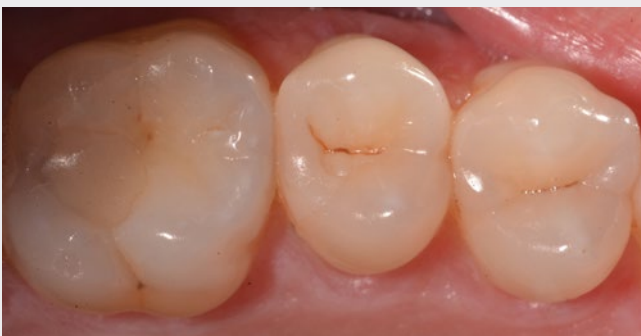
**Fig. 8.**

Treatment outcome after two months.

The present case demonstrates that the selected composite is well-suited for simplified restoration procedures in the posterior region. The material handles well, offers the same mechanical properties as other materials from the CLEARFIL MAJESTY™ ES-2 series and blends in harmoniously with the surrounding structures without being too translucent. This way, it is possible to waive the shade-taking process without compromising the treatment outcome. The time saved in this context may be spent on functional aspects – or even on another patient.
